TWO GUYS FROM TEXAS / PART 5
By Bruce Fullerton (#1712) and Robert Mace (#1713)

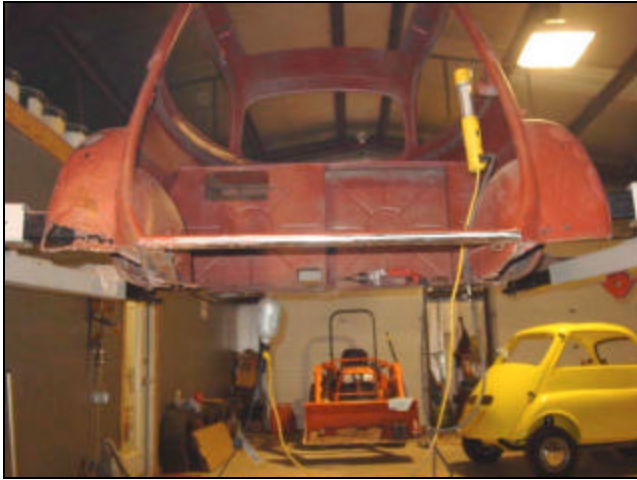
Robert's rust shrine getting its bottom flamed while Bruce's car awaits it's trip back into Austin after getting' a little lemon yellow squirted on it. The Kubota watches the action.

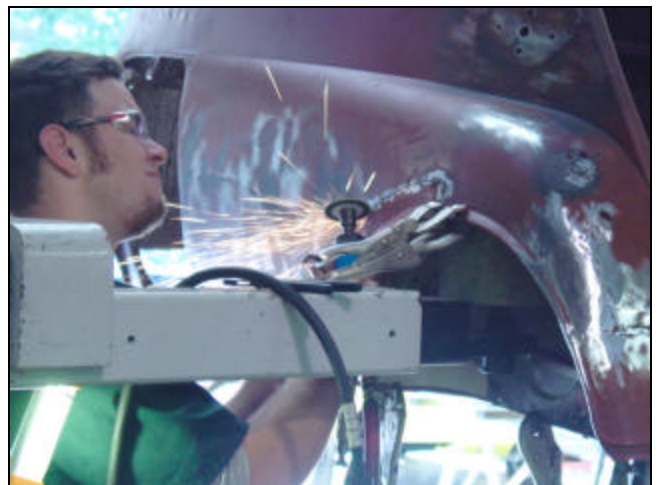
You'd think getting' your bottom flamed would be enough! Robert's car meets Mr. Grinder while the new outer wheel well panel gets fined tuned. It's getting' there!

Robert and Bruce ordered several new body replacement panels. Robert also got a new floorboard with battery box since his car was Swiss-cheese-like in the front fenders, lower side panels and floorboard.

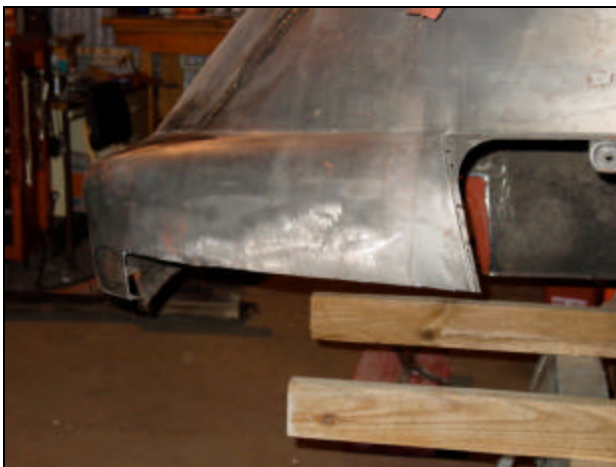
Old quarter panel has been surgically removed.

Bruce had to order a new battery box and right and left rear quarter panel. The price of the new panels were less than the cost of sheer labor to fix the old ones. The outcome confirmed it.

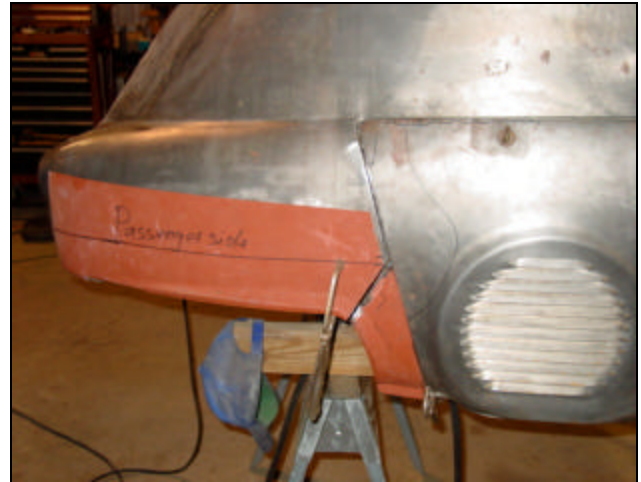
Note diagonal cut that had to be made in repro quarter panel on Bruce's car. These guys aren't stamped from original dies and, while close, this one did not fit correctly as delivered.

As you can see in the following pictures, these panels aren't all perfect fits. The right rear panel had to be cut, repositioned on the body and re-welded. Not a show stopper but it added labor to the job. These panels are NOT stamped from original or retro dies and aren't perfect. That right passenger side panel, if you need one, is the one to watch out for as you'll see.

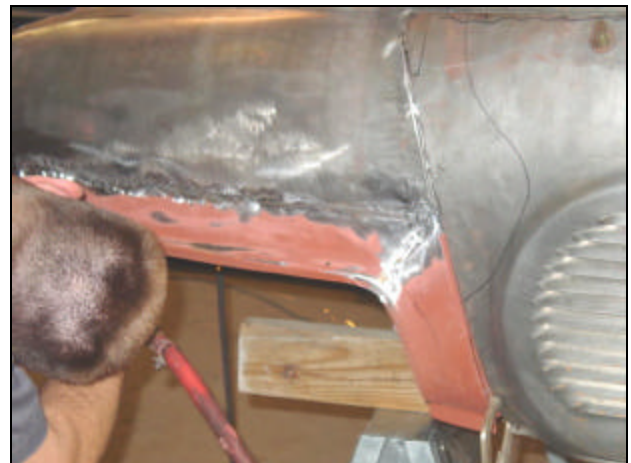
After some expert jockeying, the body shop got Bruce's new panel dialed in. Aaron Bowen of Classic Auto Works puts the finishing touches on the rough-in.

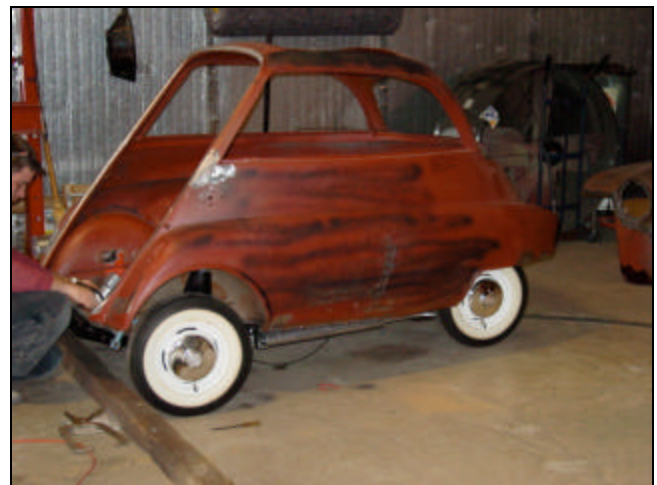
Body of Bubba's one-lung hemi parked back on chassis to check fit of new floor pan.

Plan on taking your frame with you. A real tricky part of the job (should your car have the same problem Bruce's did) is that slim piece behind the engine cover that forms the front of the rear passenger side wheel well. There is also a tab that comes off of it at the bottom that bolts to the rear of the back motor mount. That tab has to line up right and having the body on the frame is the only way to do it. (Make note that if you order a repro right quarter panel, it DOES NOT include that tab!) Another scenario is if you have a new floorboard installed, like Robert's car. That frame will be a must!
